INDOOR AIR QUALITY ASSESSMENT

**Jones Library
43 Amity Street
Amherst, Massachusetts**

Prepared by:
Massachusetts Department of Public Health
Bureau of Environmental Health Assessment
February 2001

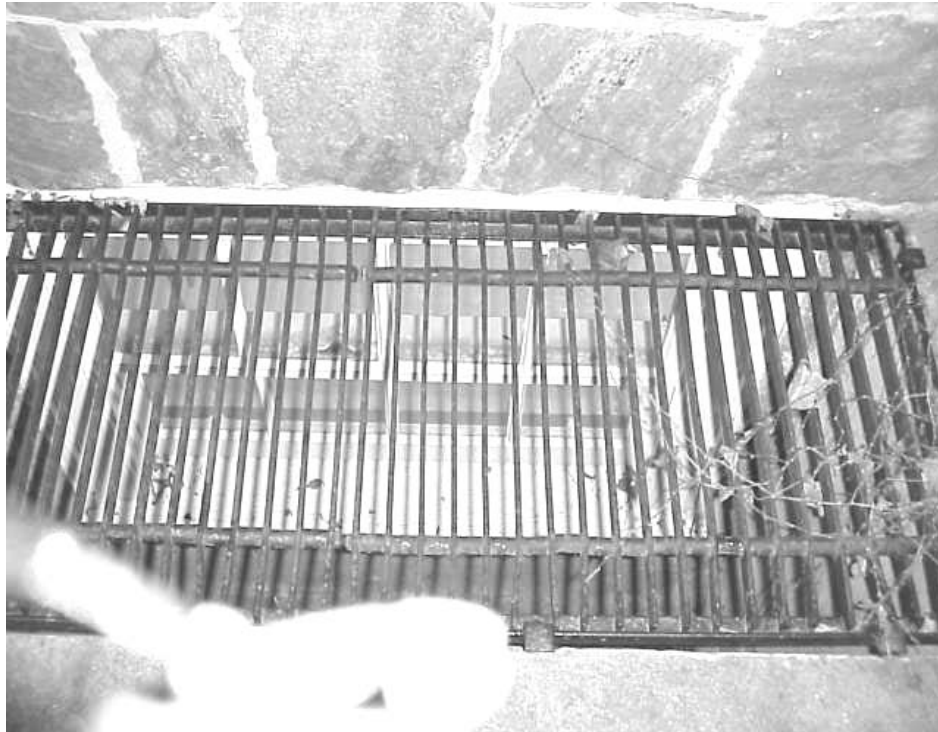
Picture 2

Craft Room Window That Opens into A Stone-Lined Pit

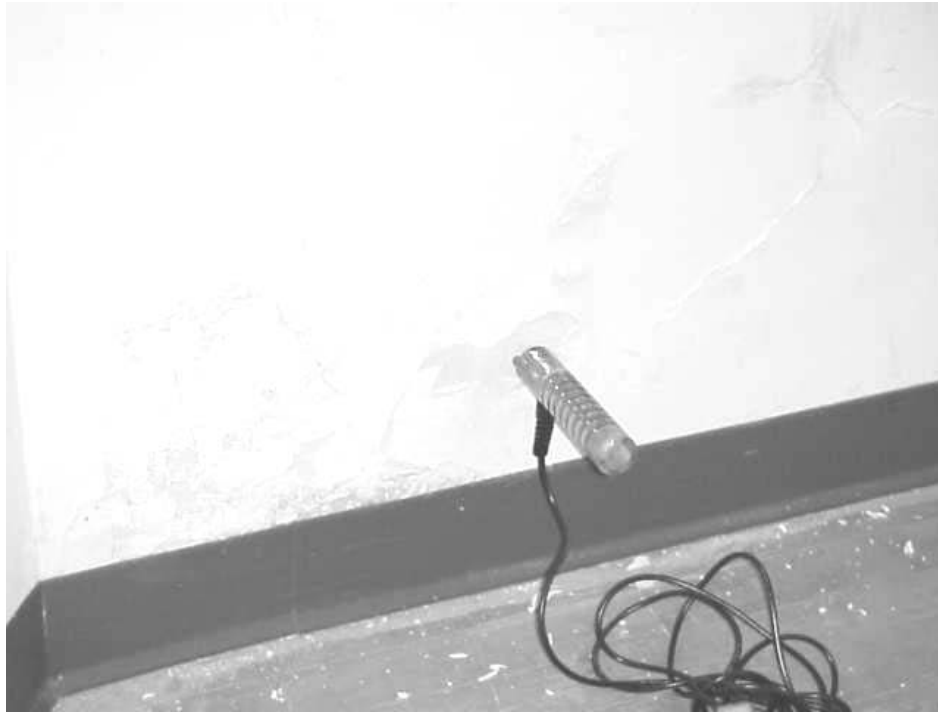
Picture 3

A Delmhorst Probe was inserted into the South Wall of the Crafts Room

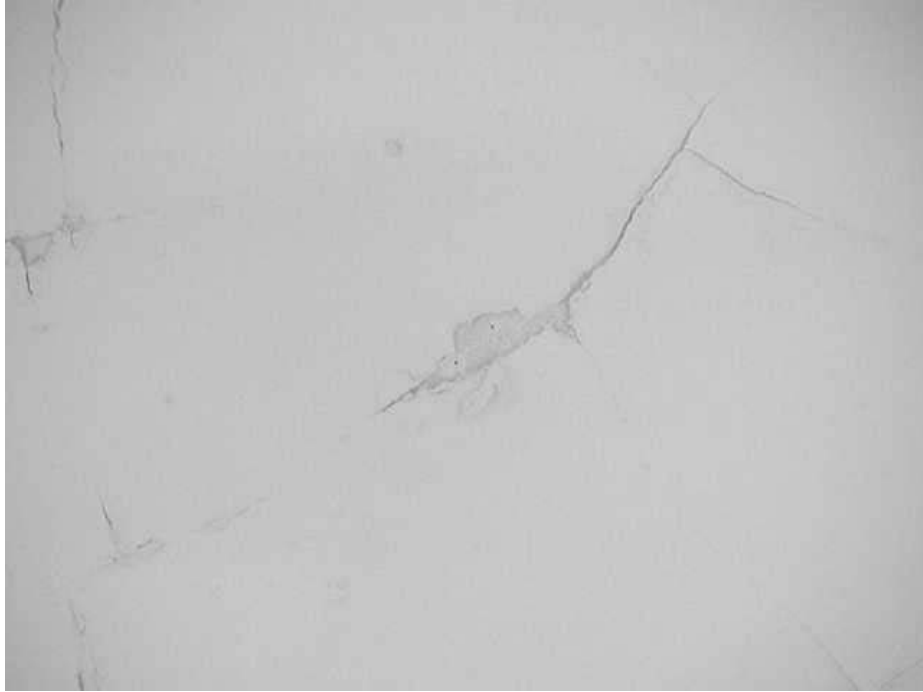
Picture 4

A number of moisture samples were taken throughout the crafts room. Moisture content of plaster and GW within the normal range (1.1 to 43.4 percent) was measured in the south wall. The variance in measured moisture concentration in different sections of plaster of the same wall may indicate some moisture exposure. The highest moisture concentration was measured in a wall crack of the south wall (see Picture 4). Please note that moisture content of GW measured is a real time measurement of the conditions present in this building on December 7, 2000. Moisture content may increase or decrease depending on building and weather conditions.

Wall Crack of the South Wall with Highest Moisture Concentration (43.4 Percent)

1. Continue with plans to repair the gutter. Provide adequate drainage to direct water away from the foundation.
2. Consider having exterior brick repointed and waterproofed to prevent further water intrusion. Repair/replace water damaged carpeting and wall-plaster as necessary.
3. The window in the crafts room should remain closed when the HVAC system is providing cooling during summer weather.

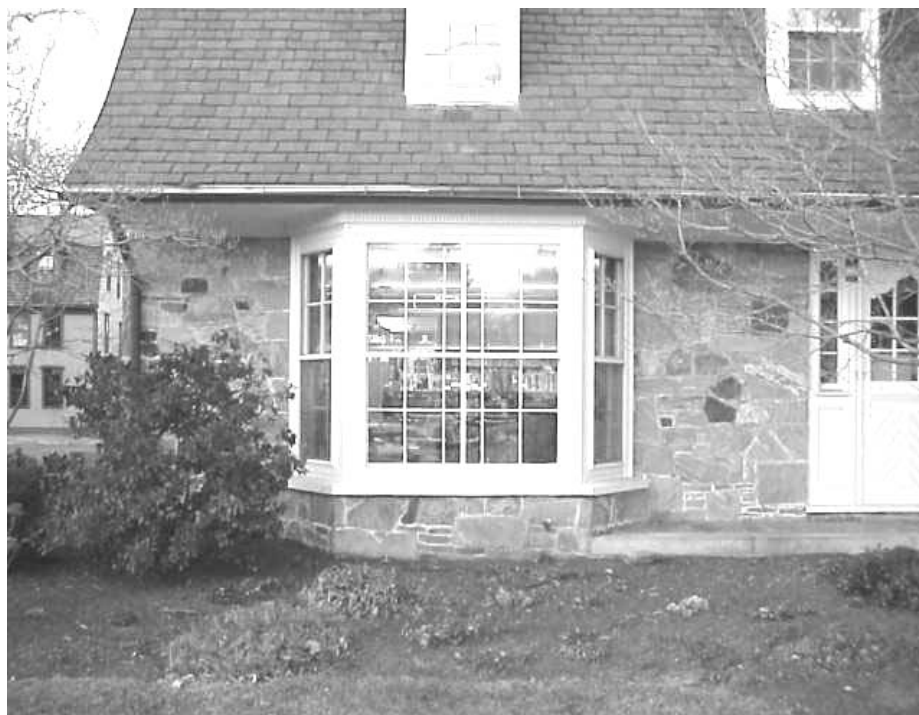
Picture 5

Moisture sources in the indoor environment can originate from several sources. While introduction by the HVAC system may occur, the most likely source of moisture appears to be water penetration through the foundation. Located above the craft room south

Edge of Roof Over Ground above the Craft Room South Wall

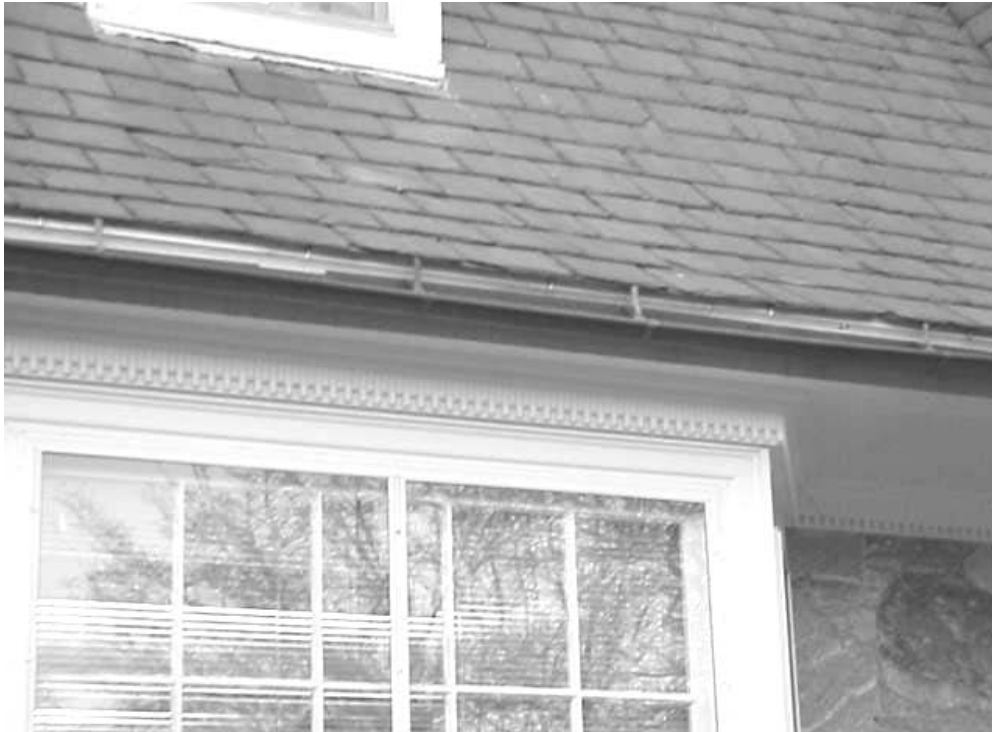
Picture 6

wall is a peaked roof (see Picture 5). A gutter and drain system exists above the south wall. The gutter appears to be bent into a shape that allows for rainwater to splash over the gutter into the soil above the south wall (see Picture 6). This condition allows for rainwater to accumulate along the base of the building, which can, in turn seep below ground along the foundation.

Bent Gutter over South Wall, Note Bent Gutter Fasteners

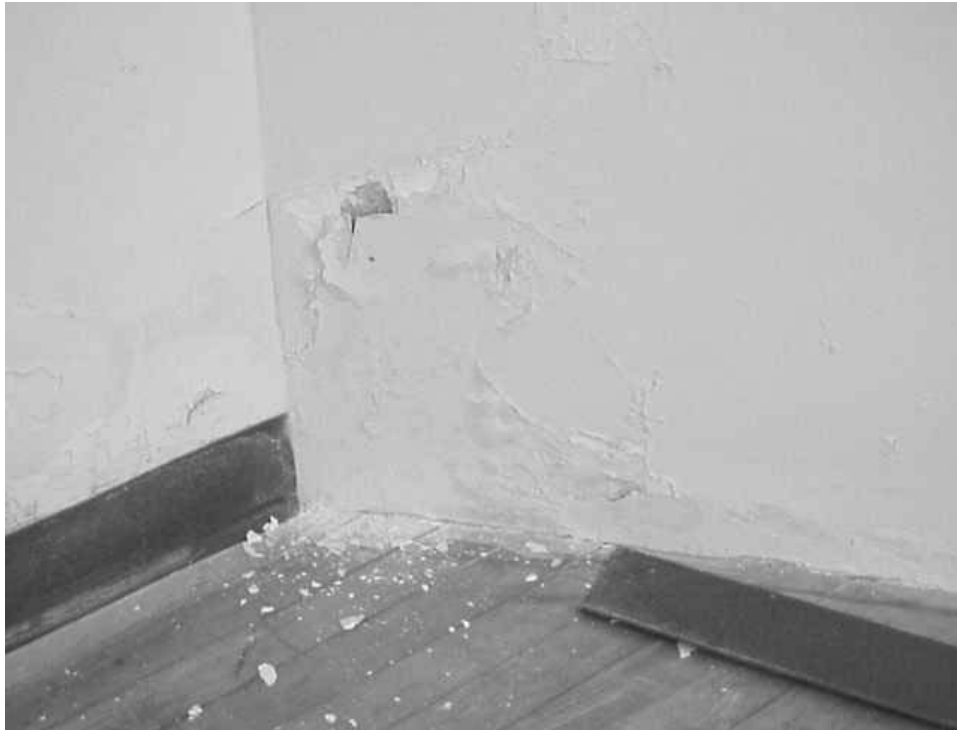
Picture 7

Efflorescence (i.e., mineral deposits) was observed on the brickwork on the interior of the south wall in several places (see Picture 7). Efflorescence is a characteristic sign of water intrusion. As moisture penetrates and works its way through mortar around brick it leaves behind these characteristic mineral deposits. Efflorescence on carpeting indicates that these materials are chronically wetted. The American Conference of Governmental Industrial Hygienists (ACGIH) recommends that porous materials be dried with fans and heating within 24 hours of becoming wet (ACGIH, 1989). If porous materials are not dried within this time frame, mold growth may occur. Once mold growth has occurred, disinfection of may be possible, however these materials are porous and appear to be wetted repeatedly, disinfection is likely to be ineffective.

Efflorescence in South Wall Plaster

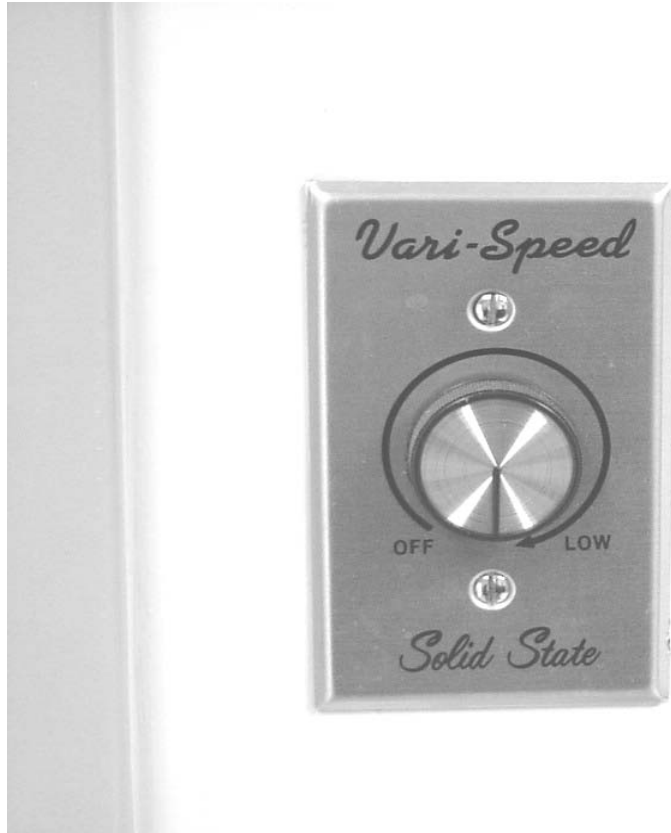
Example of Variable-Speed Fan Control Switch

4. Examine the feasibility of installing a speed control switch in place of the current wall switch so the speed of the exhaust fan blades can be adjusted (see Picture 8 for an example). Examine the louvers behind this fan for function and repair as needed.
5. Operate the exhaust fan during summer months. In addition to a speed control, examine the feasibility of installing a timer to activate the exhaust fan during business hours.
